**FT-101Z/ FT-107/ FT-707/ FT-901,902 (later version)
DISPLAY COUNTER UNIT (PB-2086A)**

**Custom Integrated Circuit (MSM9520RS)
Replacement Module**

Assembly and Installation Manual (v1.3e)

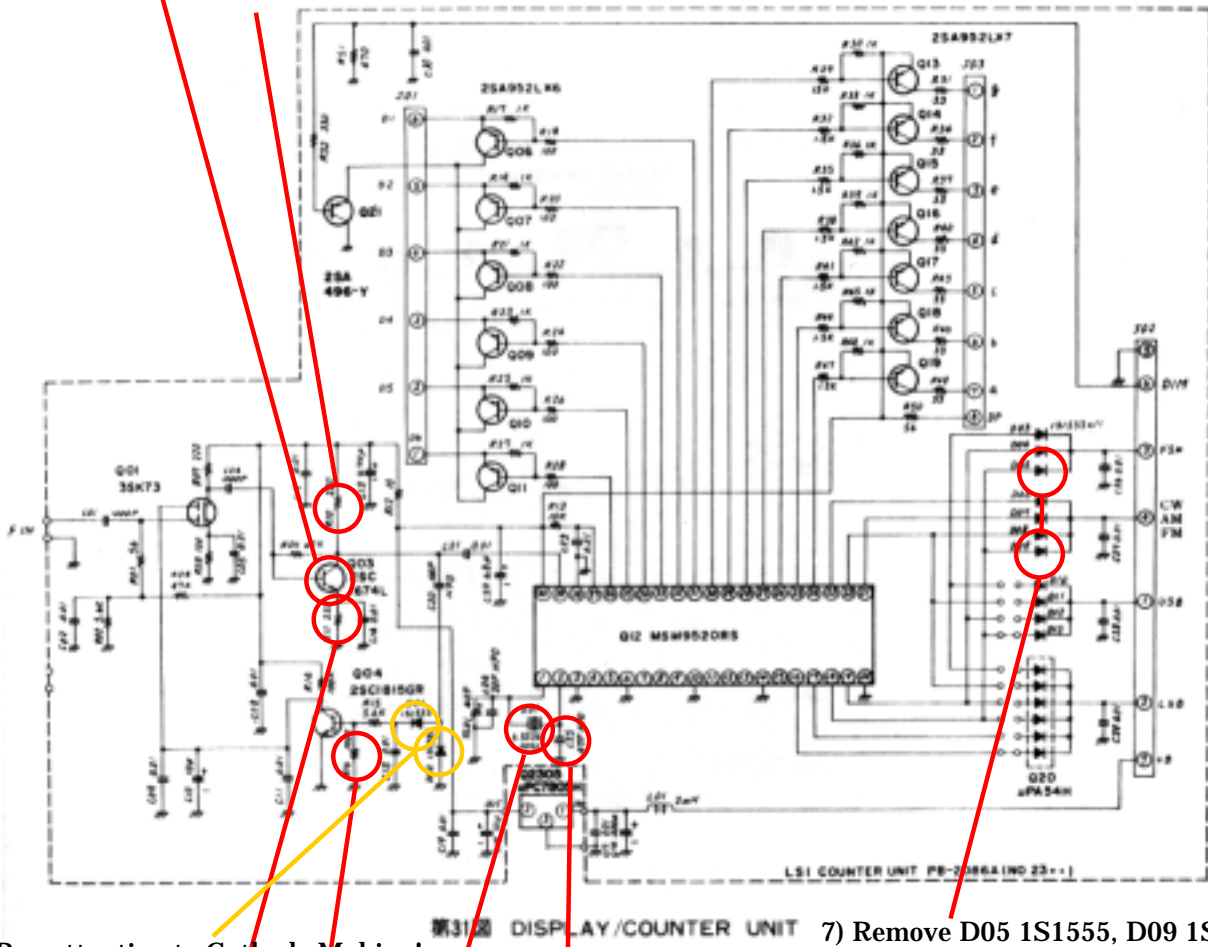
Fig. 1 DISPLAY/COUNTER UNIT Modifications

6) Replace Q03 2SC1674L with 2SC3605. (Attention: BEC Pin Ordering!)

5) Replace R10 220 Ω with 390 Ω.

Pay attention to Cathode Making!

7) Remove D05 1S1555, D09 1S1555.

2) Replace C25 47pF (Other value may have been used.) with 22pF.

1) Replace X01 6.5536MHz quartz crystal with 20.000MHz quartz crystal.

3) Replace R16 100 kΩ with 2.2 kΩ.

4) Replace R11 220 Ω with 33 Ω.

- Remove the nonfunctional MSM9520RS by unsoldering 40 pins with unsoldering wires (SOLDER-WICK) or a vacuum unsoldering gun. Then make necessary modifications of the board described below:
 - 1) Replace X01 6.5536MHz quartz crystal with 20.000MHz quartz crystal.
 - 2) Replace C25 47pF (Other value may have been used.) with 22pF.
 - 3) Replace R16 100 k Ω with 2.2 k Ω .
 - 4) Replace R11 220 Ω with 33 Ω .
 - 5) Replace R10 220 Ω with 390 Ω .
 - 6) Replace Q03 2SC1674L with 2SC3605.

- If the cathode marking of D01 1S1555 and D02 1S1555 happens to be “white”, these diodes need to be replaced. (Diodes are included in this kit.) Refer to the troubleshooting section [2) Miscounting at Higher Band] of this manual.
- Please refer to Fig. 1 and Fig. 2 for the locations of the modification on the schematic diagram and the picture of the board.

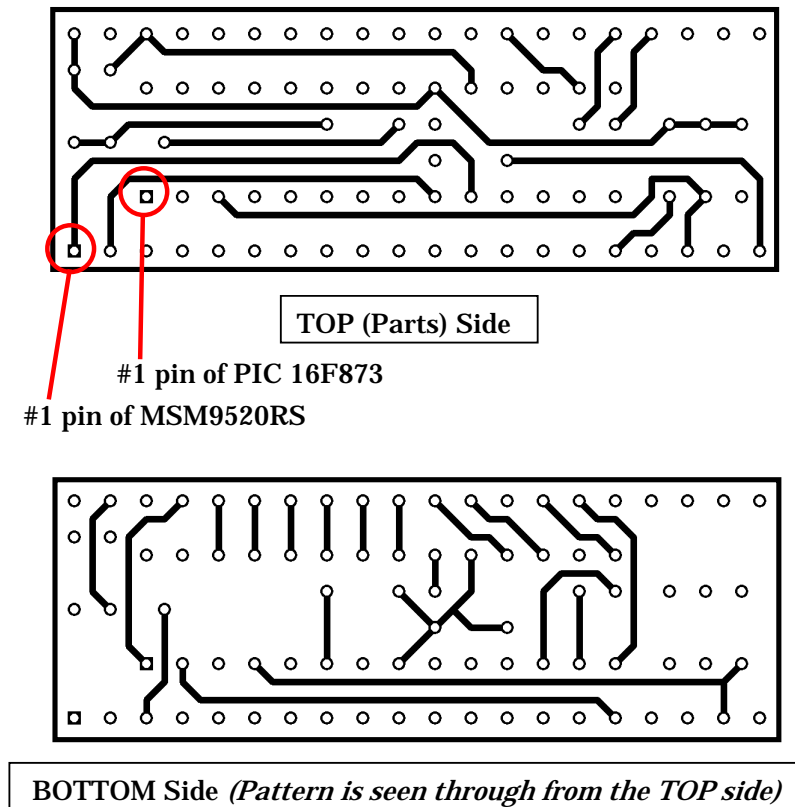
Fig. 4 Patterns of the Conversion Board for each Side

- Spend a while to determine the “sides” (TOP or BOTTOM) of the conversion board and the location of the #1 pin for the integrated circuit referring to Fig. 4.

(Step 4) Install the conversion board on the DISPLAY COUNTER UNIT and solder pin-header pins. Inset the microcontroller chip, PIC 16F873 making sure to match the #1 pin. (Refer to Fig. 4 for the location of the #1 pin)

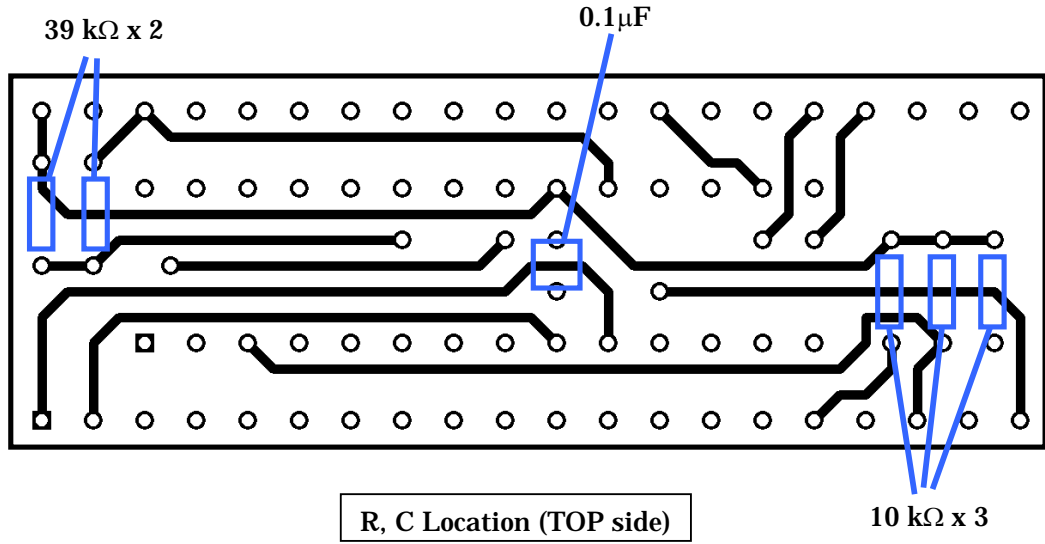
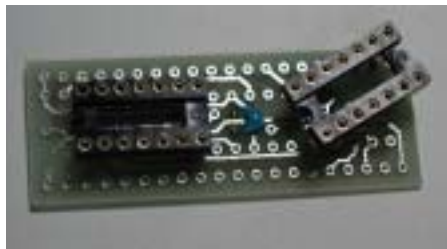
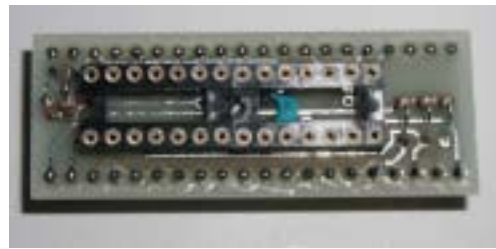
Fig. 5 TOP Side Assembly

- Assemble and solder the following parts to the TOP side of the board.
 - 1) Bypass capacitor 0.1 μ F (1 of each) for PIC 16F873.
 - 2) Pull-up resistors 10k Ω (3 of each) for the mode select logic.

- 3) Biasing resistors $39\text{k}\Omega$ (2 of each) for the input circuit of the counter. (PIC 16F873)
- 4) 28 pin DIP socket for PIC 16F873. (Use 2 of 14-pin DIP socket.)

- ◆ The 0.1 μ F bypass capacitor needs to be bended to fit under the socket.
- ◆ Use thin, pointed soldering iron to work with thin patterns and pads.
- ◆ The pads (rounded soldering patterns for parts leads) of the board are somewhat smaller to route one connecting line between 1/10 inch of DIP IC pins. Since holes of the boards are all plated conducting holes, it is advisable that the leads of parts are cut immediately at the soldering surface of the board, not bend along with the pattern, then solder the lead by “pouring” small amount of high quality solder.
